MICROGUARD[®]

CASE STUDY: Gaidos Seafood Restaurant — Galveston, Texas

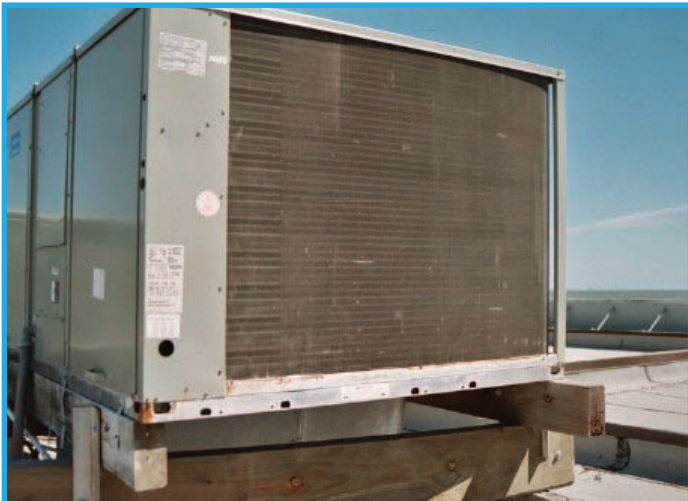
Cabinet shines like new!

Results: After 18 months, the coils/fins, cases and fan blades are all in excellent condition. Fins are attached to coil tubes resulting in the retention of conductive heat transfer and designed energy efficiency. Fins are pliable and can be bent without breaking or cracking.

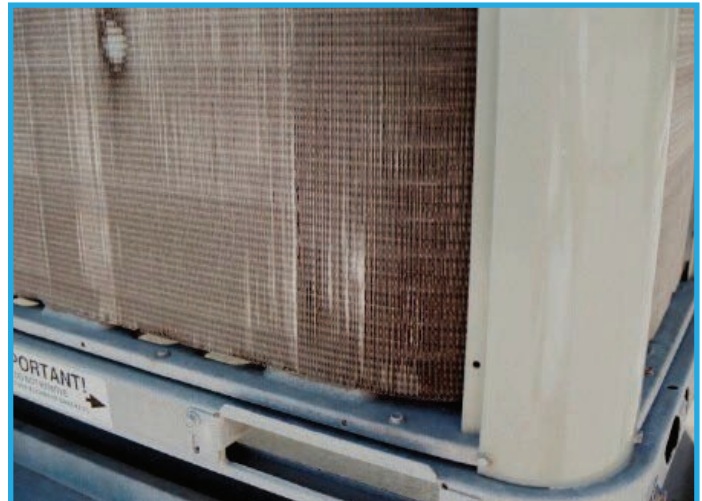
No corrosion on the coil edges!
