CASE STUDY: Lignite Coal Burning Power Plant — Northeast Texas

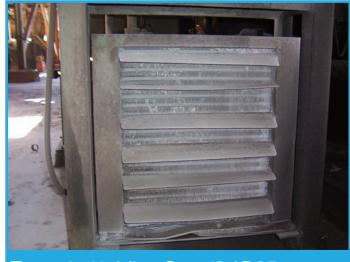
Treated with MicroGuard® AD35

Results: After one year, the MicroGuard® AD35 treated heat exchanger exhibited a one degree loss of heat transfer, while the uncoated exchanger showed a 26 degree loss. The MicroGuard® treated unit looks better and is easier to clean and maintain. The fins/coils do not clog up with contaminates like the untreated unit. Corrosion was greatly diminished on the treated unit.

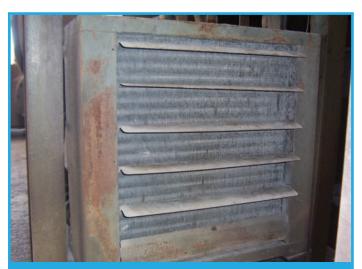
Untreated heat exchanger
