# MICROGUARD®

Concrete Surface Sealer

## CASE STUDY: Industrial Bathroom Floor Solution Truck Manufacturing Plant – Elkhart, IN

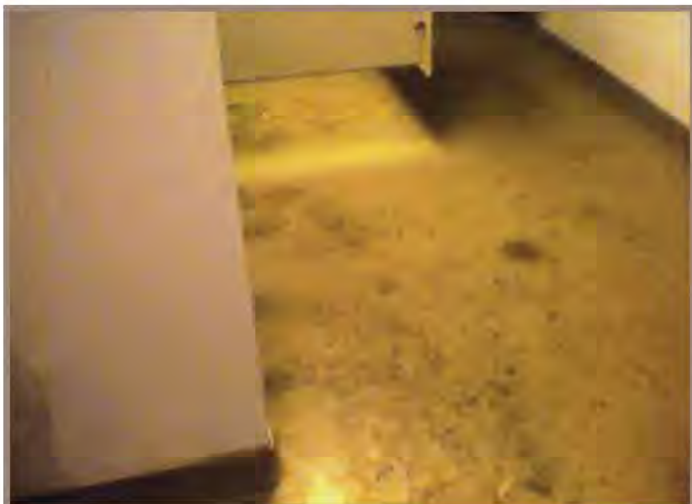
Before Treatment

**Problem:** Employees working in the spray booth were tracking paint overspray from epoxy, urethane and zinc-rich coatings onto the bathroom floors located adjacent to the spray booth. Maintenance could not remove the residues from these tracked coatings without also removing the epoxy floor paint.

**Solution:** Diamond grind floor surface to expose bare and stable concrete. Apply a self-leveling floor epoxy/quartz system to establish uniform base. Apply one coat of MicroGuard® AD703 Concrete Clear Gloss Treatment and allow to cure for 5 days.

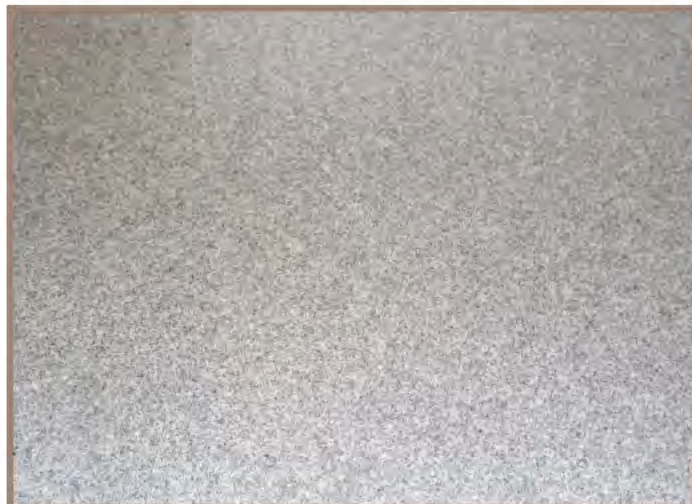
After treatment with MicroGuard® AD703

**Results:** Paint residues can now be removed using methylene chloride based paint stripper and without damaging the MicroGuard® clear treatment. Stripper residues are then removed using MicroKleen™ PLC-1 Cleaner & Degreaser.
